EVALUATION OF EPOXIES TO
PROVIDE STRESS-FREE BONDING
OF PYROCERAM MIRRORS.

PREPARED FOR
NIGHT VISION & ELECTRO-OPTICS
LABORATORY, FT. BELVOIR, VA 22060

CONTRACT No. DAAK70-77-C-0186

MAR 1979

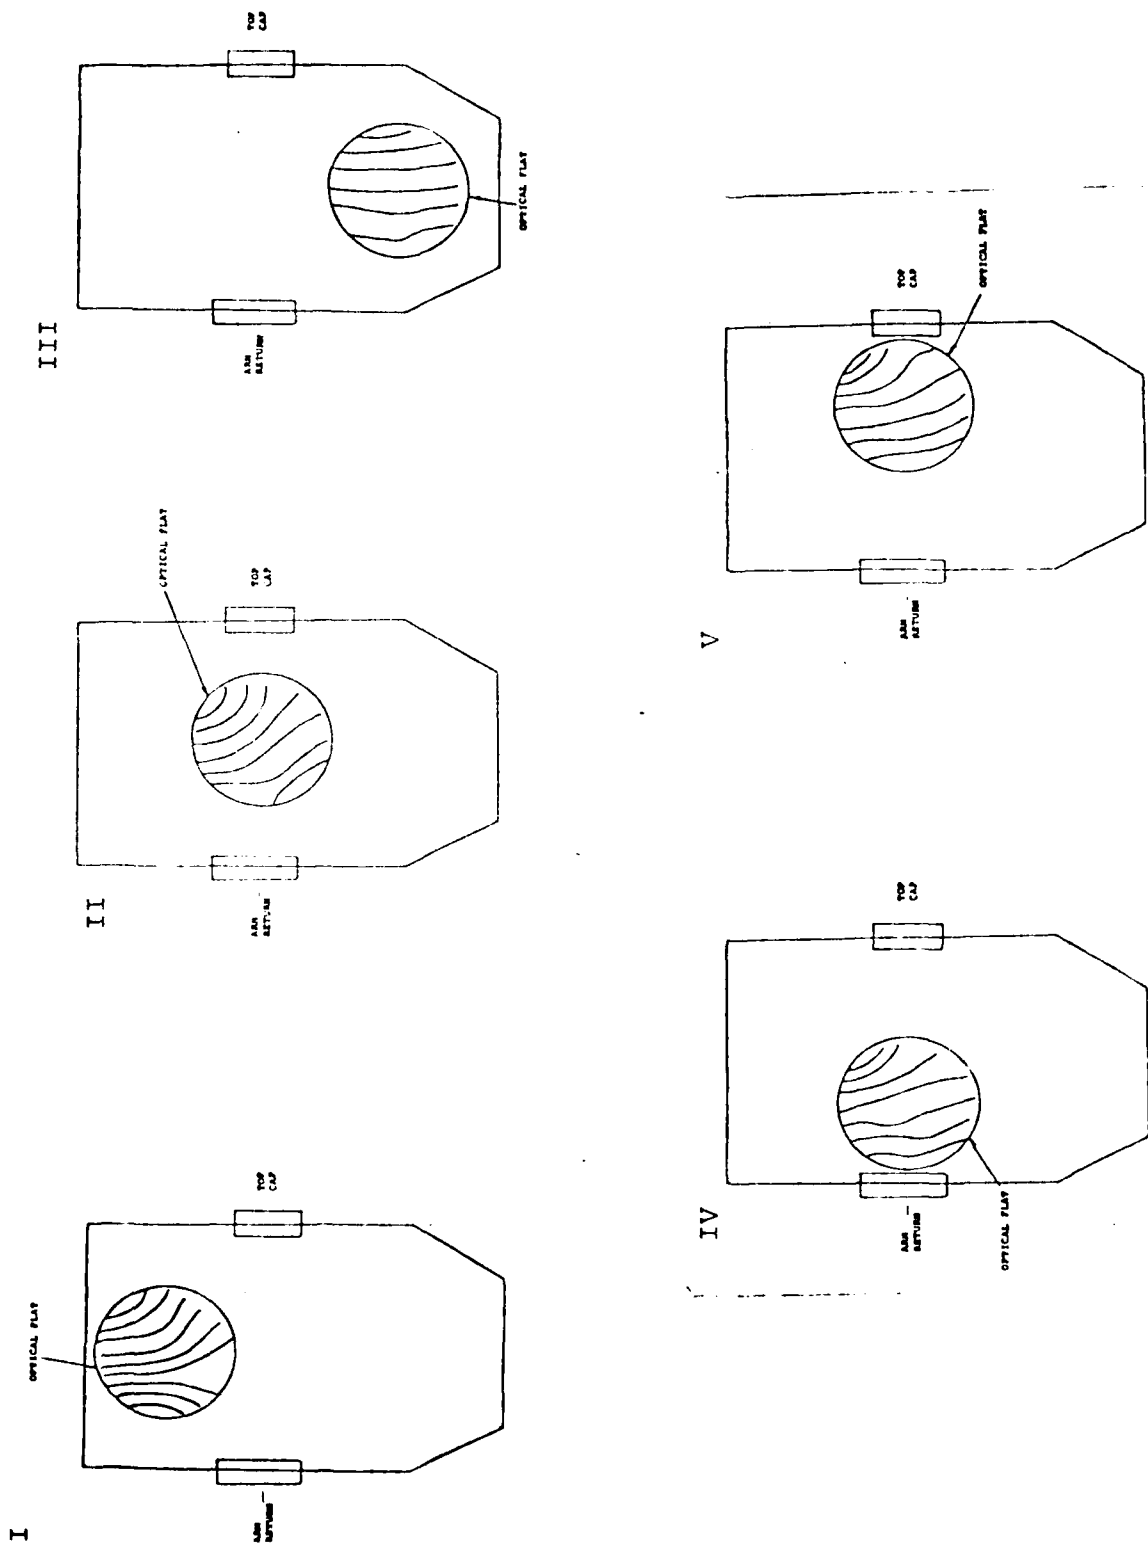
FIGURE 1. OPTICAL FLAT SURVEY OF TEST MIRROR

supported on the IR side by means of blocks and a felt pad. Using a monochromatic light source, the interferometric patterns were obtained using a small optical flat. The flat was placed at various points on the test unit surface. The sketches shown in Figure 1 are essentially what was observed. The immediate reaction of the optical expert at TWO was that the mirror had been distorted by the metal parts cemented to it. The curvature of the lines across the center (II) and at either mounting point (IV or V) showed that the epoxy had hardened in such a way that the flatness of the surface had been disturbed. When the optical flat was moved closer to either mount, the curvature of the patterns increased. TWO then stated that this effect was typical. Whenever two parts or metal to glass were joined this happened. Further, the effects shown by such assemblies on the optics were not predictable.

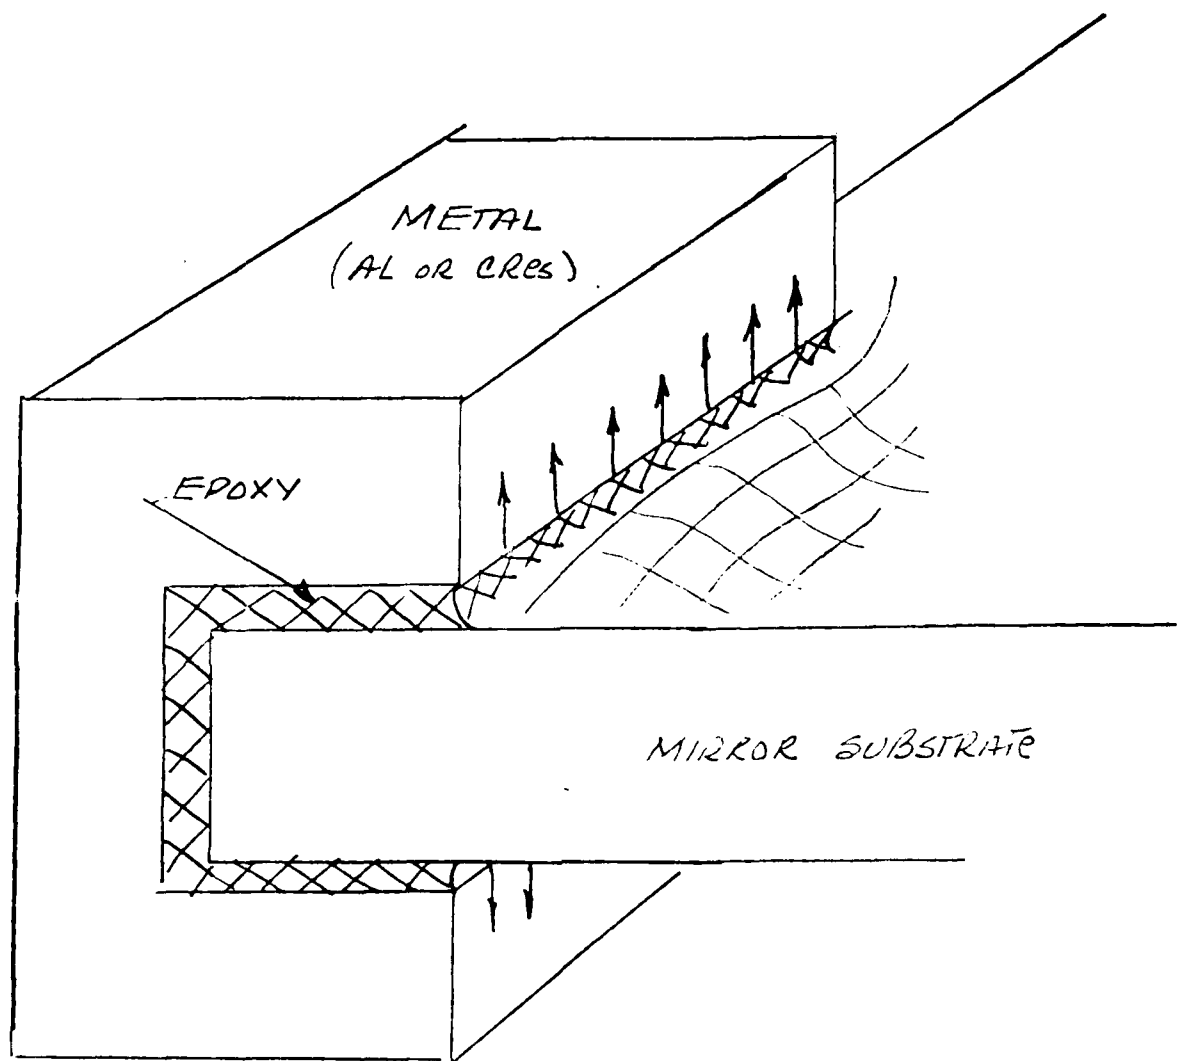
Figure 2. MIRROR SUBSTRATE - METAL BOND

A careful examination of the mounting structure was then made. Figure 2 is a sketch of the interface in question. The epoxy cement fills in the space between the mirror and the metal support structure (either aluminum in the arm return or stainless in the top cap.) The epoxy is then cured and becomes a hard material which adheres to both pieces with sufficient strength to survive repeated temperature and mechanical vibratory cycles.

Now, in the process of curing, the epoxy goes through a chemical change and as a rule tends to shrink while adhering to both interface surfaces. In the figure shown, the force resulting from this shrinkage is represented as a series of vertical arrows on the upper and lower surfaces of the mirror. With such a force distribution, two conditions are possible. First, if the mirror had zero thickness, these forces would tend to cancel. Second, if the mirror substrate was perfectly rigid, the surface would not react to this force. However, neither of these conditions exist. Thus the reaction to these forces is such that the mirror surface would tend to move (however minutely) and result in a deviation from optical flatness. Moreover, the resultant distortion would go beyond the contacting surface dimensions since the substrate must have a gradual diminishment versus linear distance. A general representation of this distortion is sketched onto the surface in Figure 2.

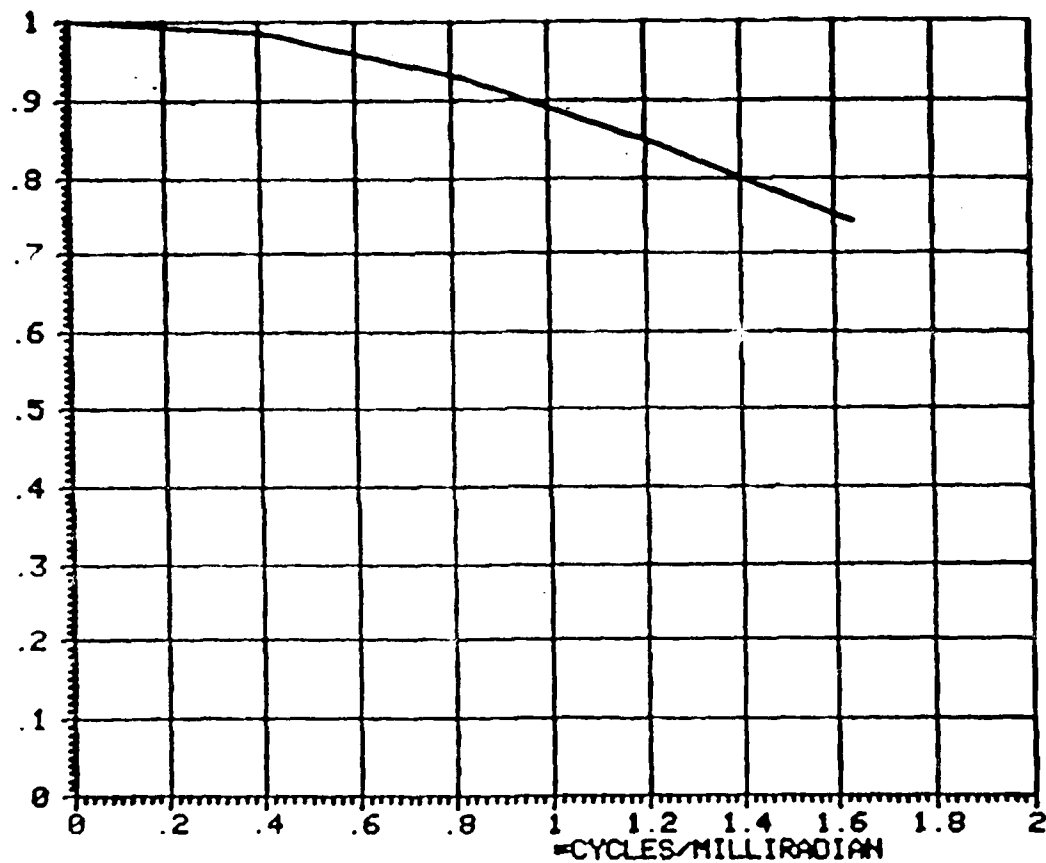
FIGURE 10

Figures 10 and 11 are print outs of the MTF curves achieved for both the Visible and IR sides under dynamic conditions. From this curve, the MTF at .667 cycles/milliradian is 95% or slightly better for both sides. This met the specification. There was an improvement of about 2-3% from the test results obtained previously on this unit (before heat treatment cycling). The static MTF performance of the mirror was also measured.

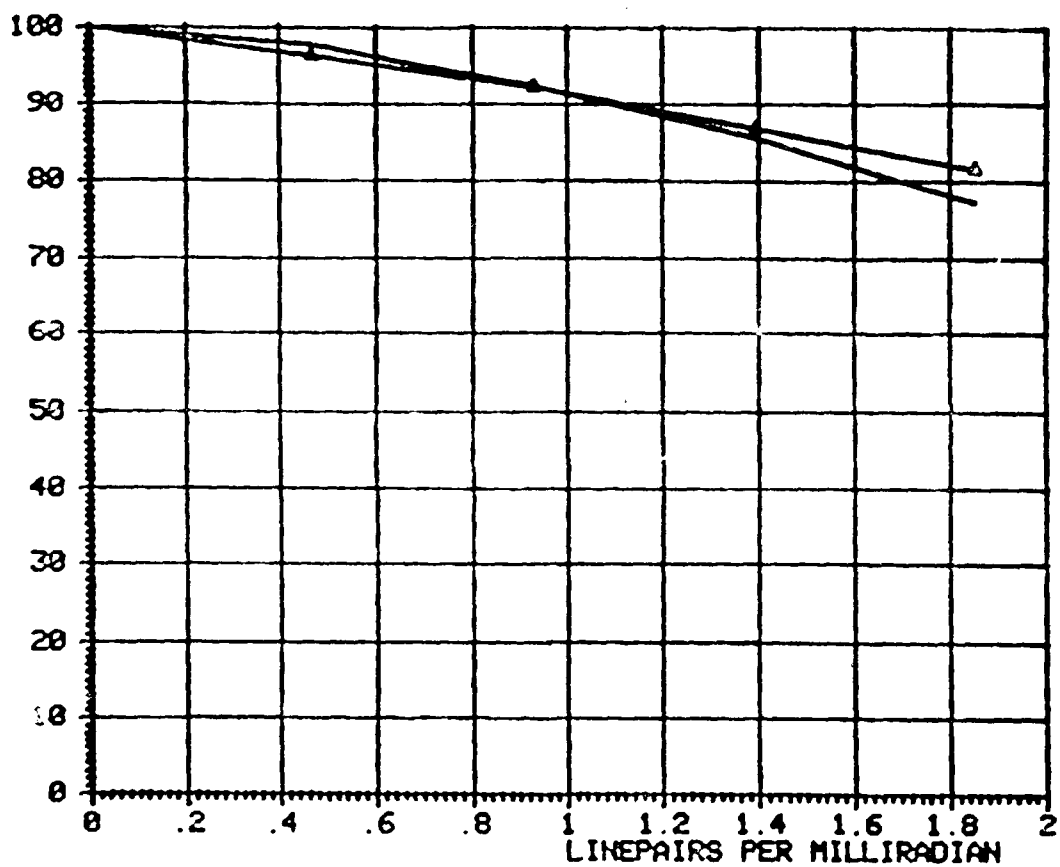
FIGURE 15

Figure 15 and 16 show the results obtained on Mirror #001 for the static MTF test. As can be seen, the MTF in the azimuth plane, as well as the elevation plane, meet the specification requirement for both sides. In particular, there was a marked improvement in the elevation plane response.

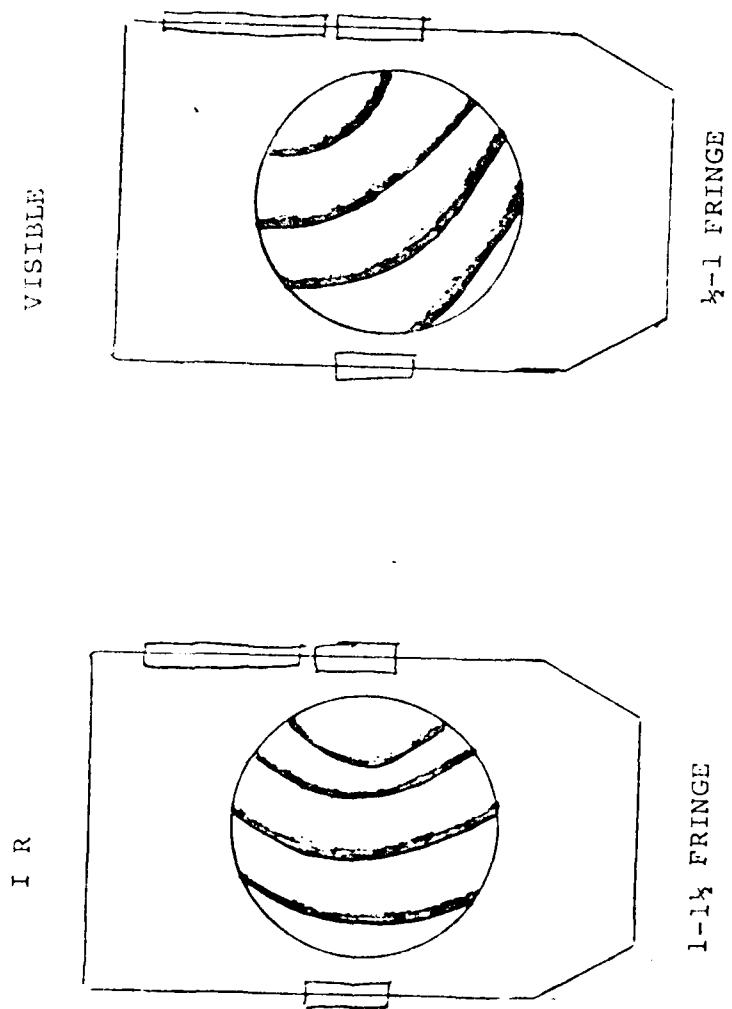
FIGURE 40. S/N 007 FRINGE PATTERNS

Data was taken at each point to determine stress points and distortion in the mirror before the cementing operation took place and where possible distortion was eliminated. The mirror was also permitted to air cure for 72 hours before the NVL cure cycle was initiated. An optical flat survey was made of the mirror both before the cementing cure and before the high temperature/low temperature cycles were initiated. The interferometric patterns showed that a $1/4$ to $1/2$ fringe mirror resulted in an increase in distortion of approximately $1/2$ to 1 fringe regular. When the curing cycle had been completed, a further survey was made of the mirror and resulted in an optical flat survey showing $1-1\frac{1}{2}$ fringes with some irregularity of the surface (Figure 40).

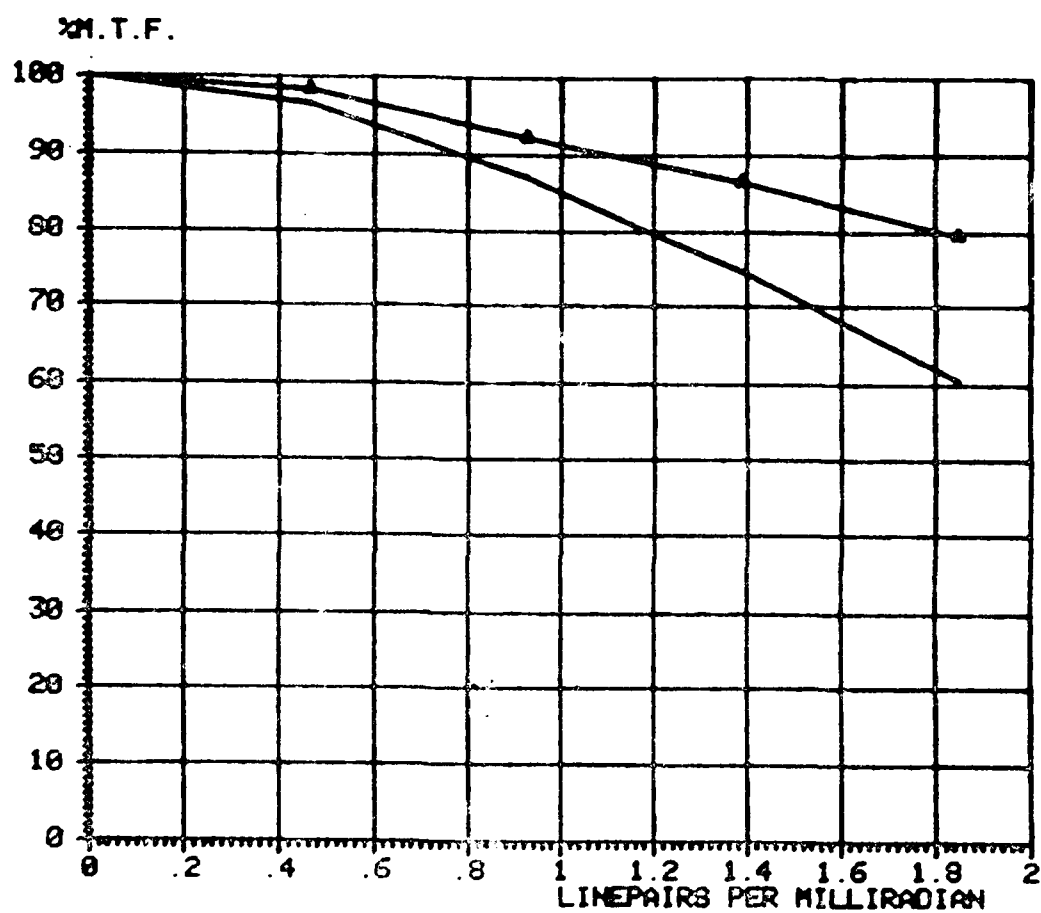
FIGURE 51. MTF RESPONSE, I R SIDE, S/N 008A

The MTF response for the IR side shows that the astigmatism resulting after cycling has caused this mirror to fail the MTF requirements. Figure 51 indicates that the astigmatism is in the elevation plane and review of the interferogram could yield such a conclusion but only to an expert eye.

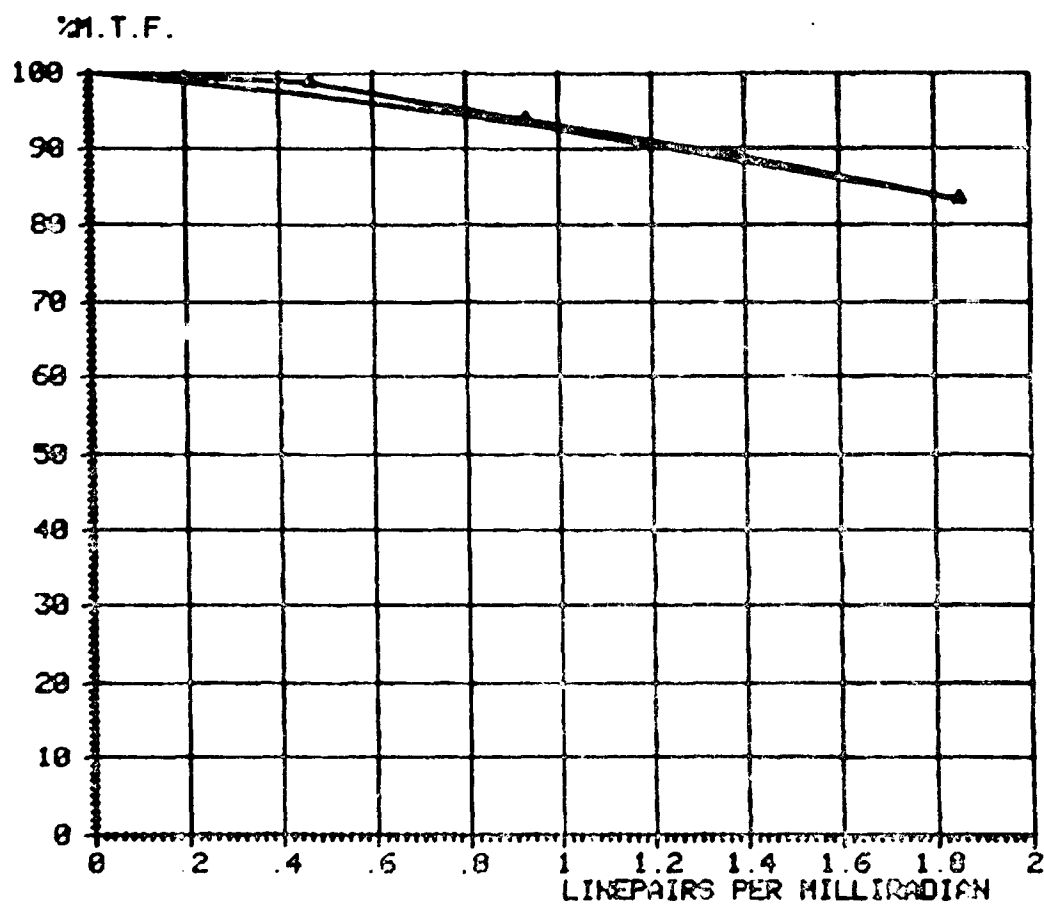
FIGURE 52. MTF RESPONSE, VISIBLE SIDE, S/N 008A

The Visible side MTF (Figure 52) shows a better response than the IR but also misses the required MTF at .667 Lp/mm. Here the interferogram shows more regularity in the pattern but the saddling has affected the overall MTF response.

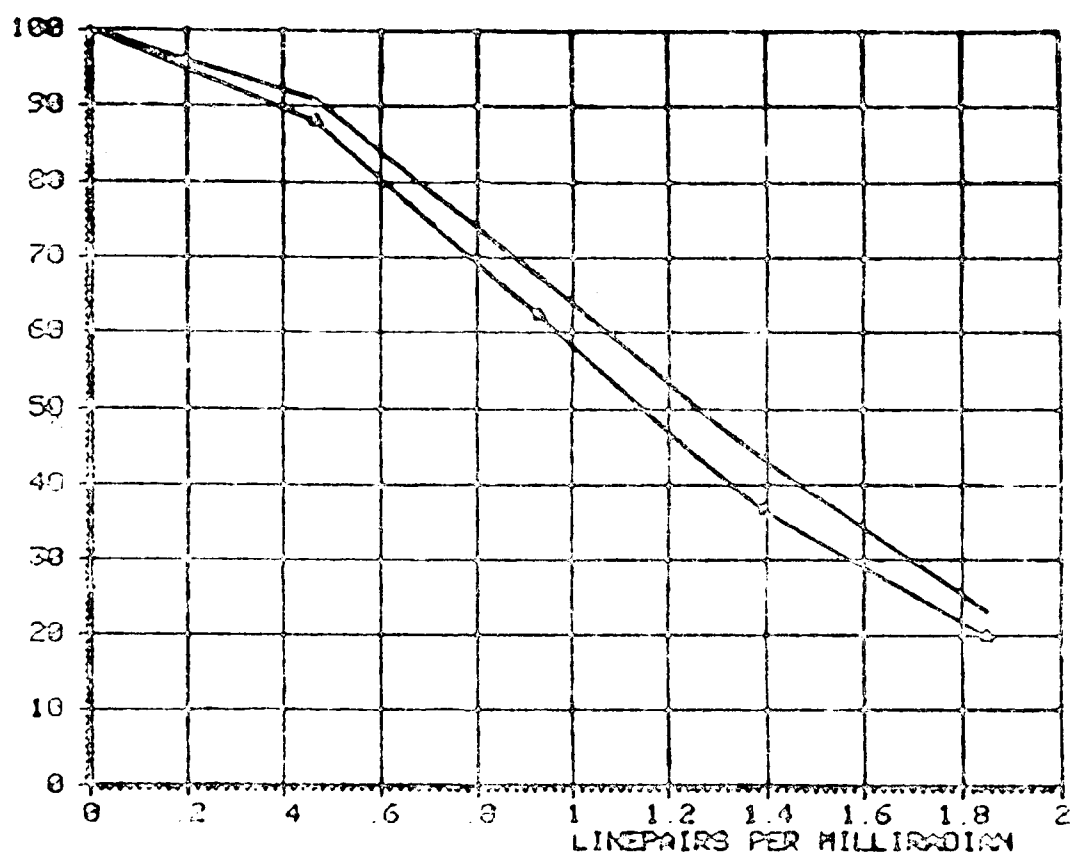
FIGURE 54. MTF RESPONSE, IR SIDE, S/N 009

Figure 54 is a plot of the MTF response achieved and shows a very poor performance. This was to be expected considering the interferogram shown on Figure 53, but the quantitative degradation in MTF could not be predicted.

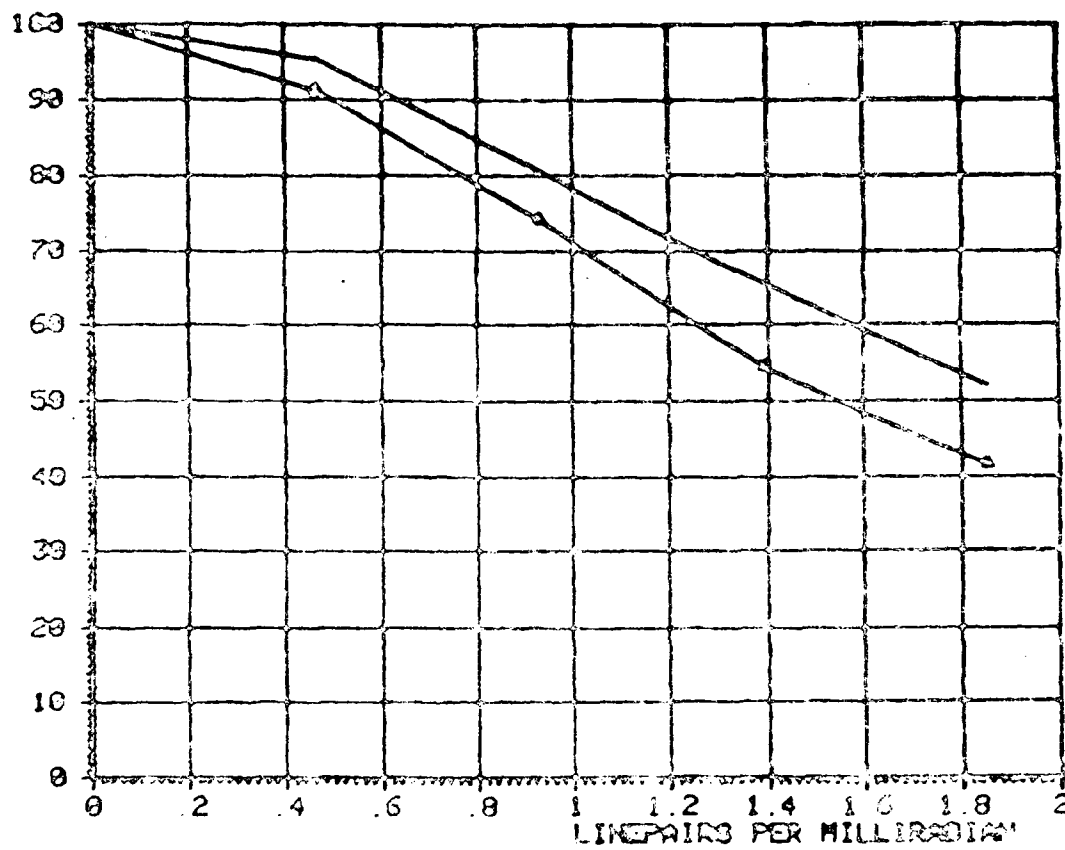
FIGURE 55. MTF RESPONSE, VISIBLE SIDE, S/N 009

Figure 55 is a plot of the MTF response achieved for the Visible side of the same mirror and shows some improvement from the IR side but is still below specification.

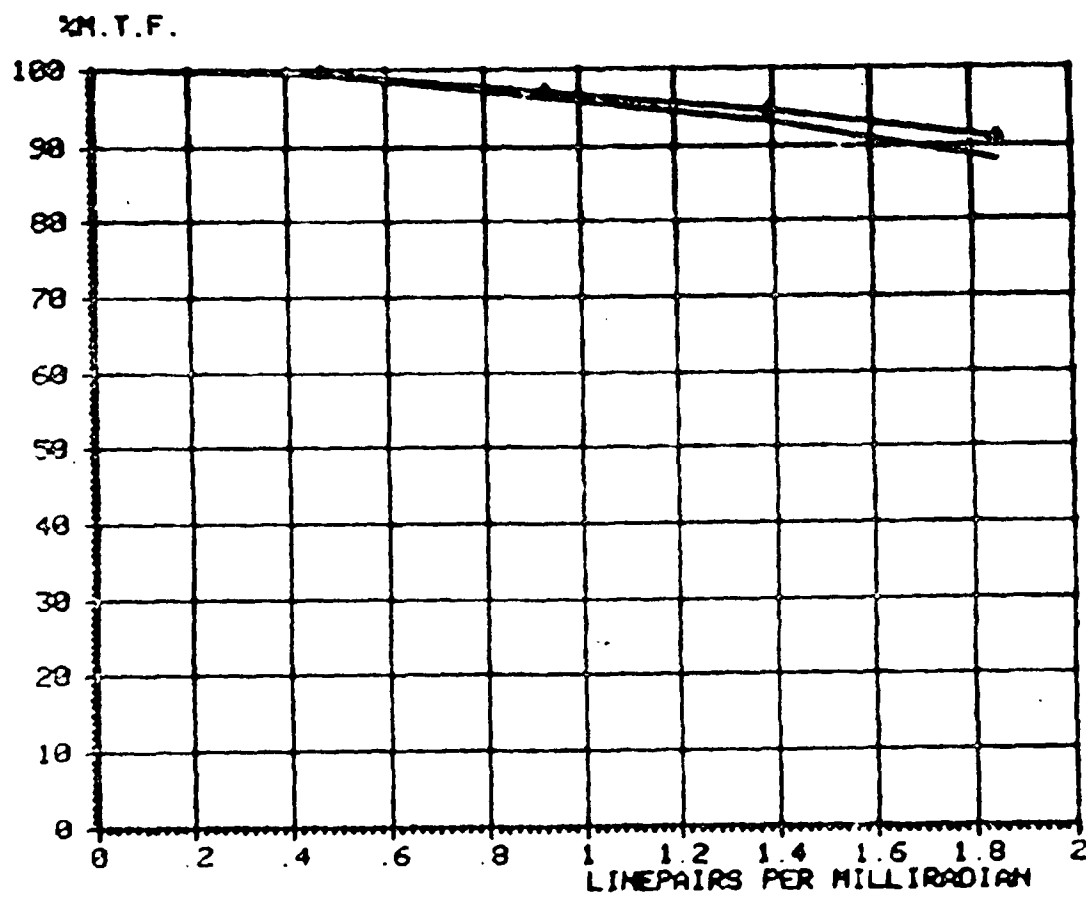
FIGURE 57. MTF RESPONSE, IR SIDE, S/N 009A

Figure 57 is a plot of the MTF response of the IR side of this mirror. As can be seen from the plot, the results were excellent to say the very least.

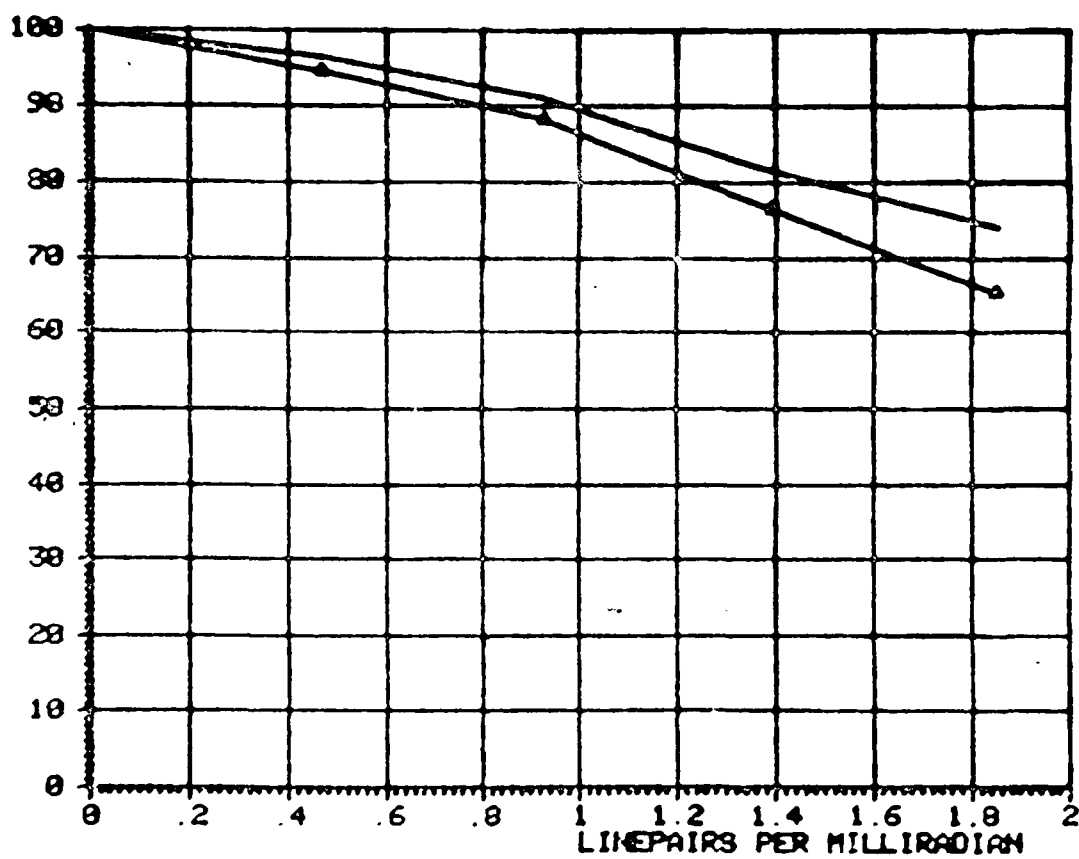
FIGURE 60. MTF RESPONSE, IR SIDE, S/N 011

Figure 60 is a plot of the MTF response of Mirror #011 and while it is improved from Mirror #009, it still shows sufficient astigmatism and droop to consider it as having failed the MTF test requirement. Figure 61 is a plot of the Visible side with essentially the same results.

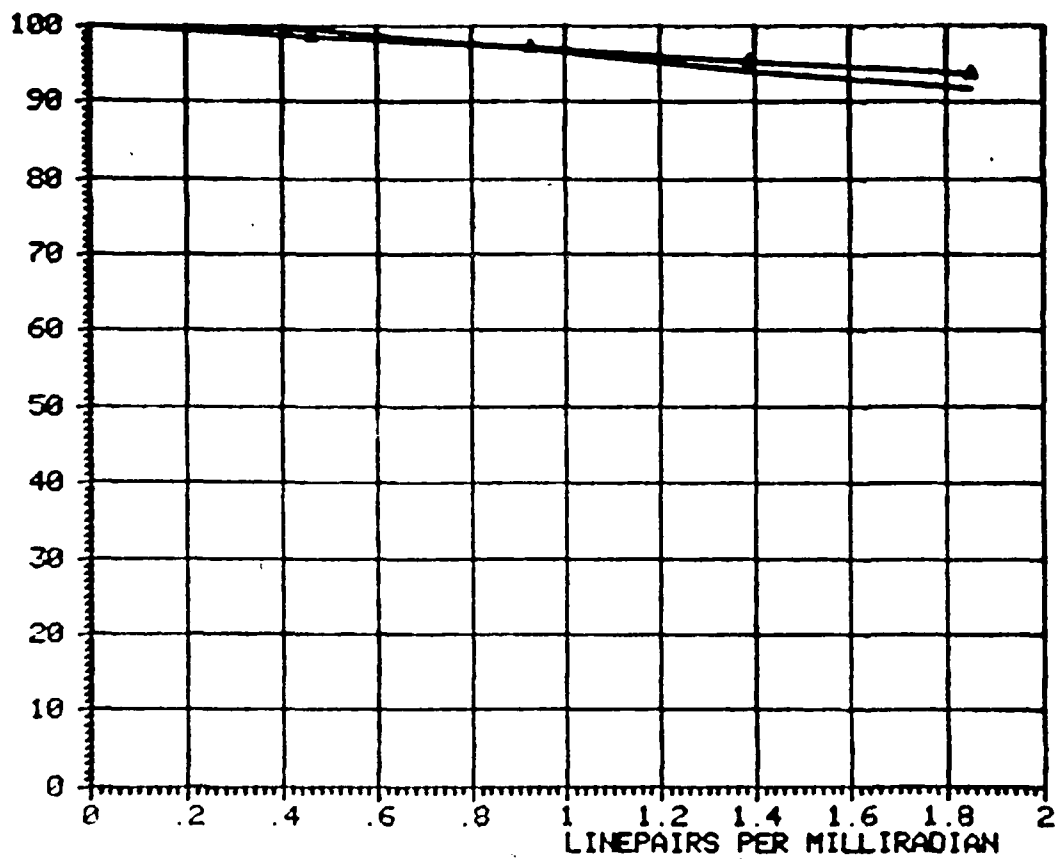
FIGURE 65. MTF RESPONSE, IR SIDE, S/N 009B

The assembly was then placed into a scanner and the scanner was aligned and tested to the ATP. Subsequent to the ATP, the scanner was taken to NVL for both static and dynamic MTF tests. Figure 65 is a plot of the IR side static MTF test results. To say the very least, the same mirror which failed using Stycast has now passed the required MTF limit admirably. Figure 66 is a plot of the Visible side MTF with equally dramatic results.

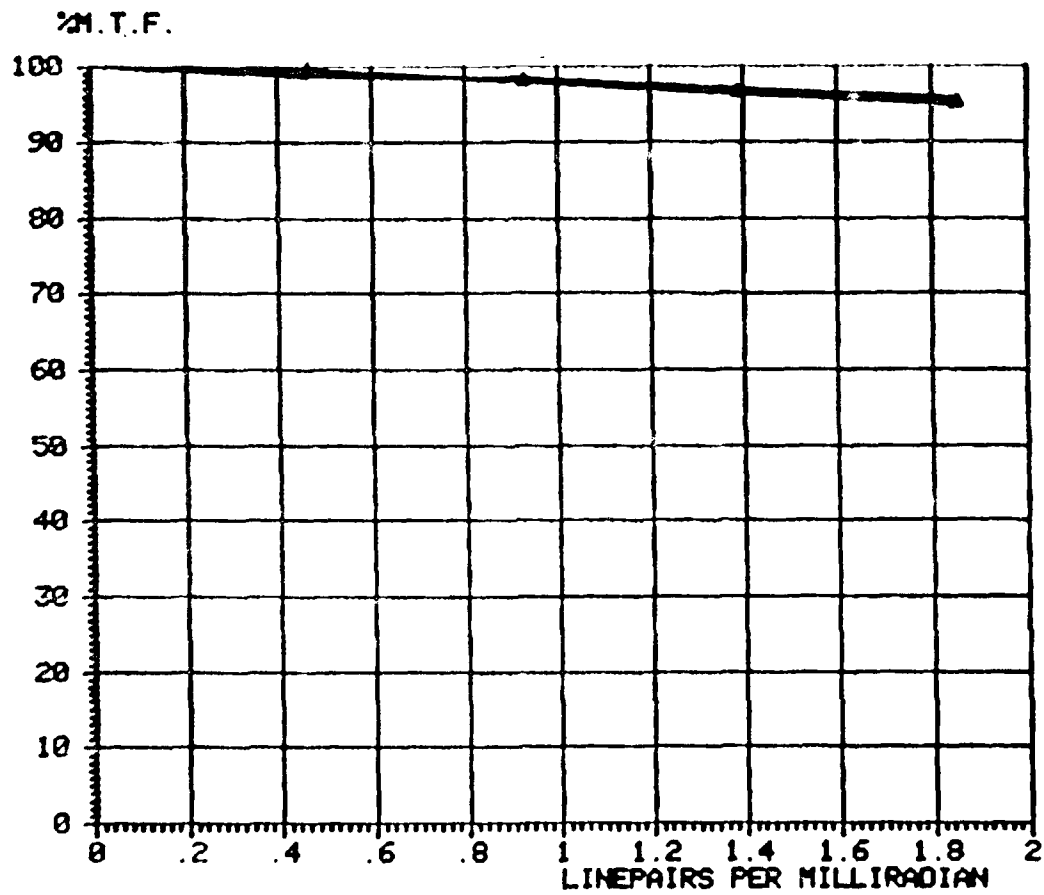
FIGURE 96. MTF RESPONSE, IR SIDE, S/N 018

The resultant MTF responses are also excellent. Figure 96 is a plot of the IR side response. Here the MTF passes .95 at 1/8 Lp/mr with no apparent astigmatism.
